**PRE-CERCLIS SCREENING ASSESSMENT  
JACLYN HOSIERY MILL  
CAMDEN, SOUTH CAROLINA  
KERSHAW COUNTY  
SCS 123 457 624**

**U.S. ENVIRONMENTAL PROTECTION AGENCY  
Region 4  
61 Forsyth Street  
Atlanta, Georgia 30303**

**South Carolina Department of Health and Environmental and Control  
Division of Site Assessment and Remediation  
Federal & State Site Assessment Section  
2600 Bull Street  
Columbia, South Carolina 29201**

**September 25, 2014**

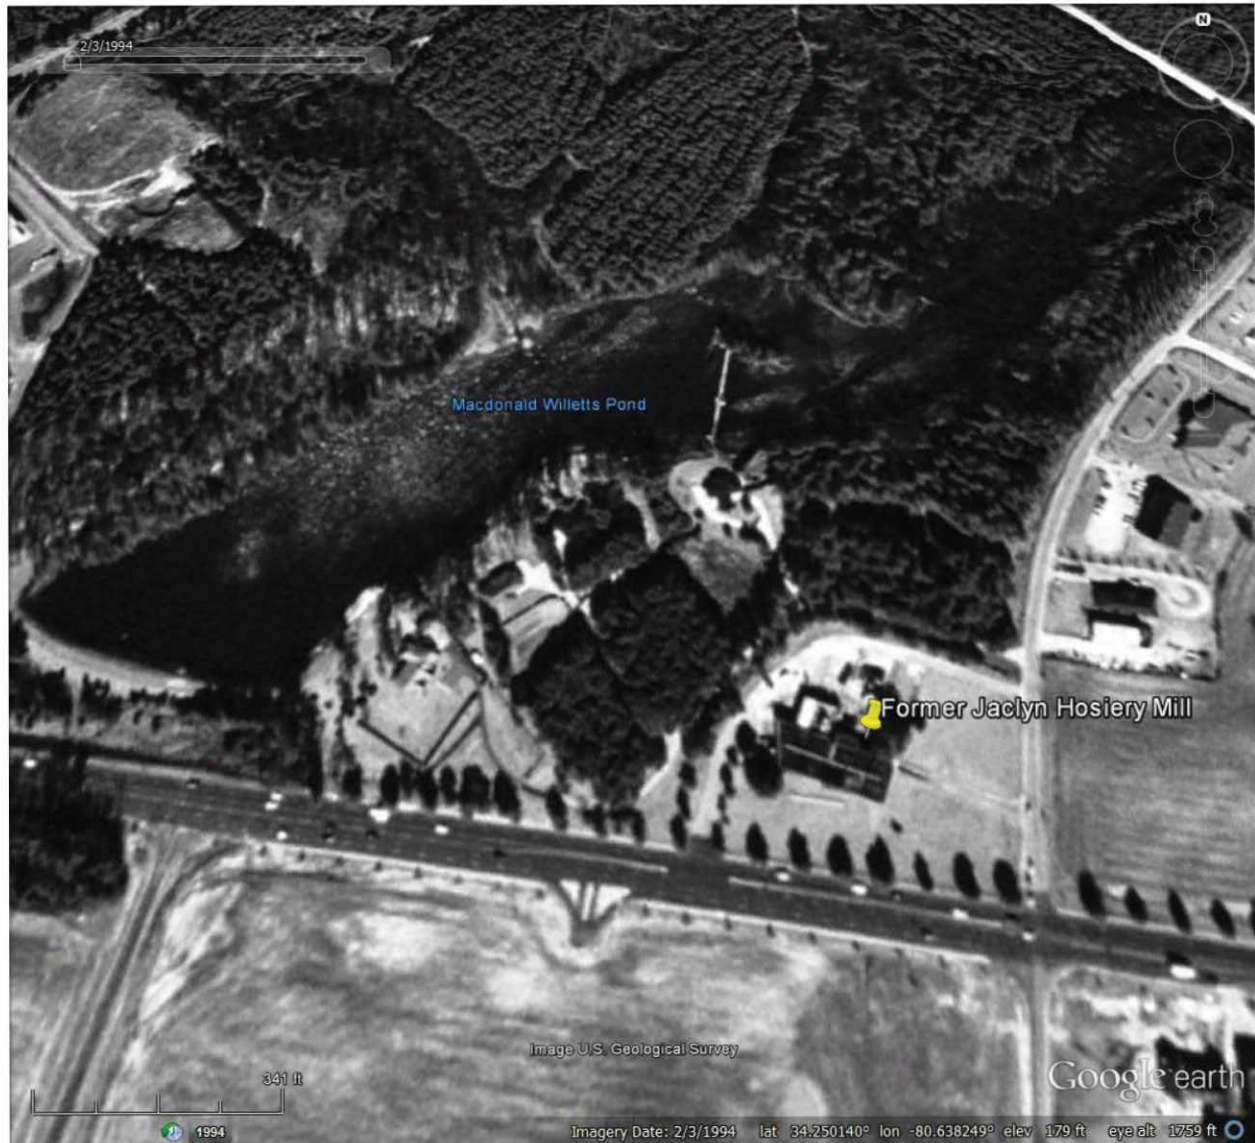
Figure 3 – Jaclyn Hosiery Mill – 1994 Aerial showing on-site structures

The mill was built and began operating in 1947 by Joseph Bossong. The mill was in operation for 28 years and Joseph's daughter Evelyn Baldauf was president. The structures were torn down between 1994 and 2005 based on available aerial photography (Ref. 1).

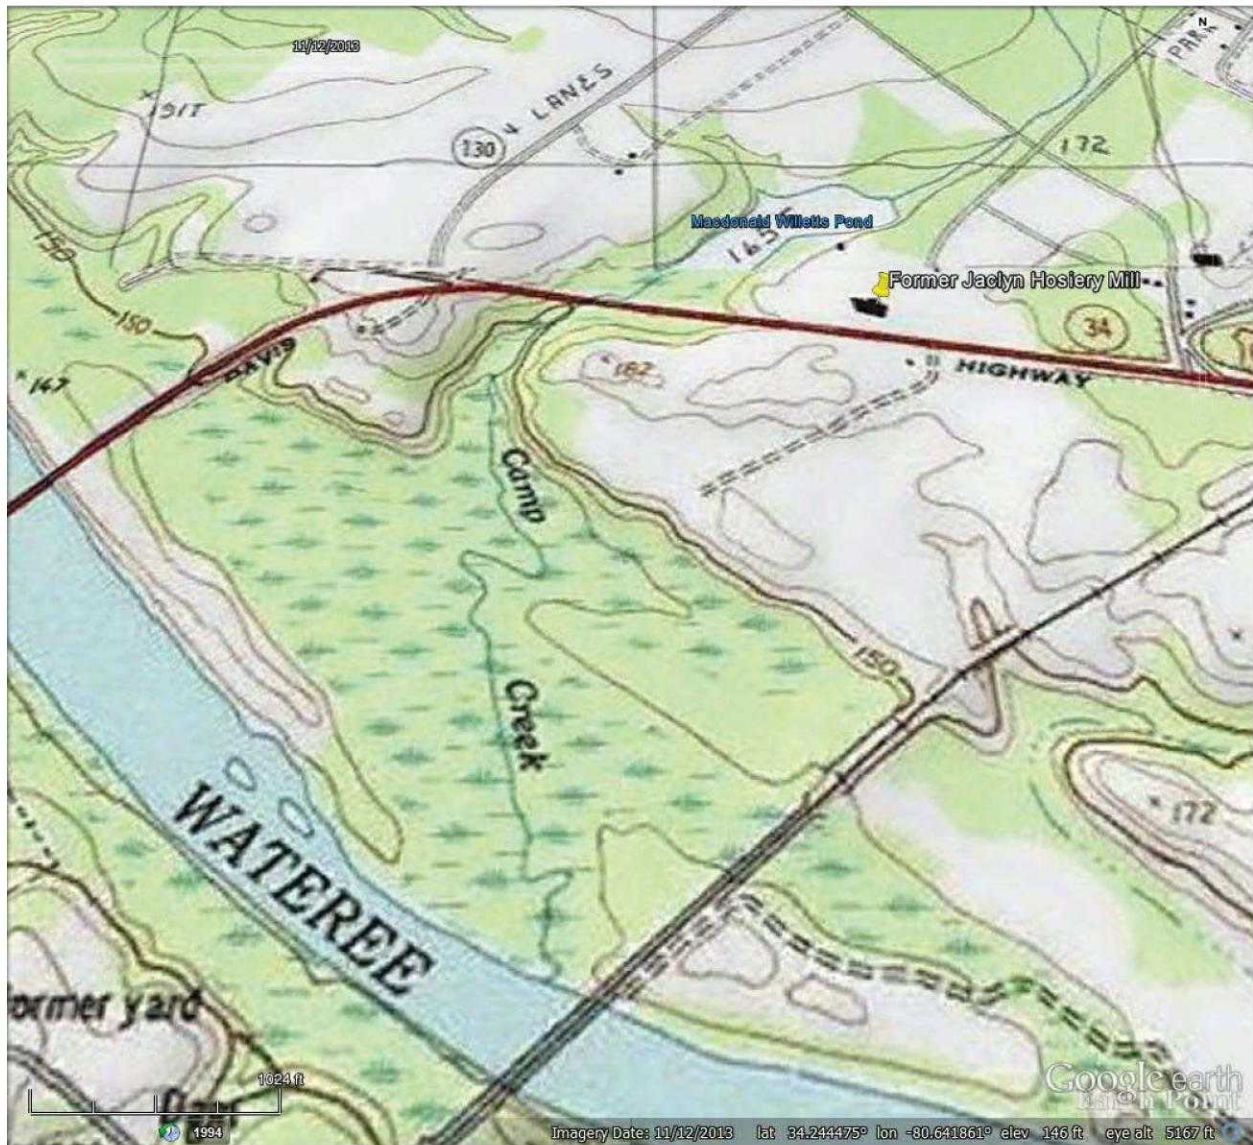
Figure 4 – Jaclyn Hosiery Mill – topo showing surface water pathway

There are no well-defined runoff pathways leaving the site. The nearest perennial surface water is a MacDonald Willetts Pond, located approximately 750 feet west of the former mill. The pond discharges to Camp Creek, which flows about ¾-mile before entering the Wateree River. Due to the lack of a defined runoff pathway and lack of wastewater-producing operations at the site, the surface water pathway will not be evaluated.

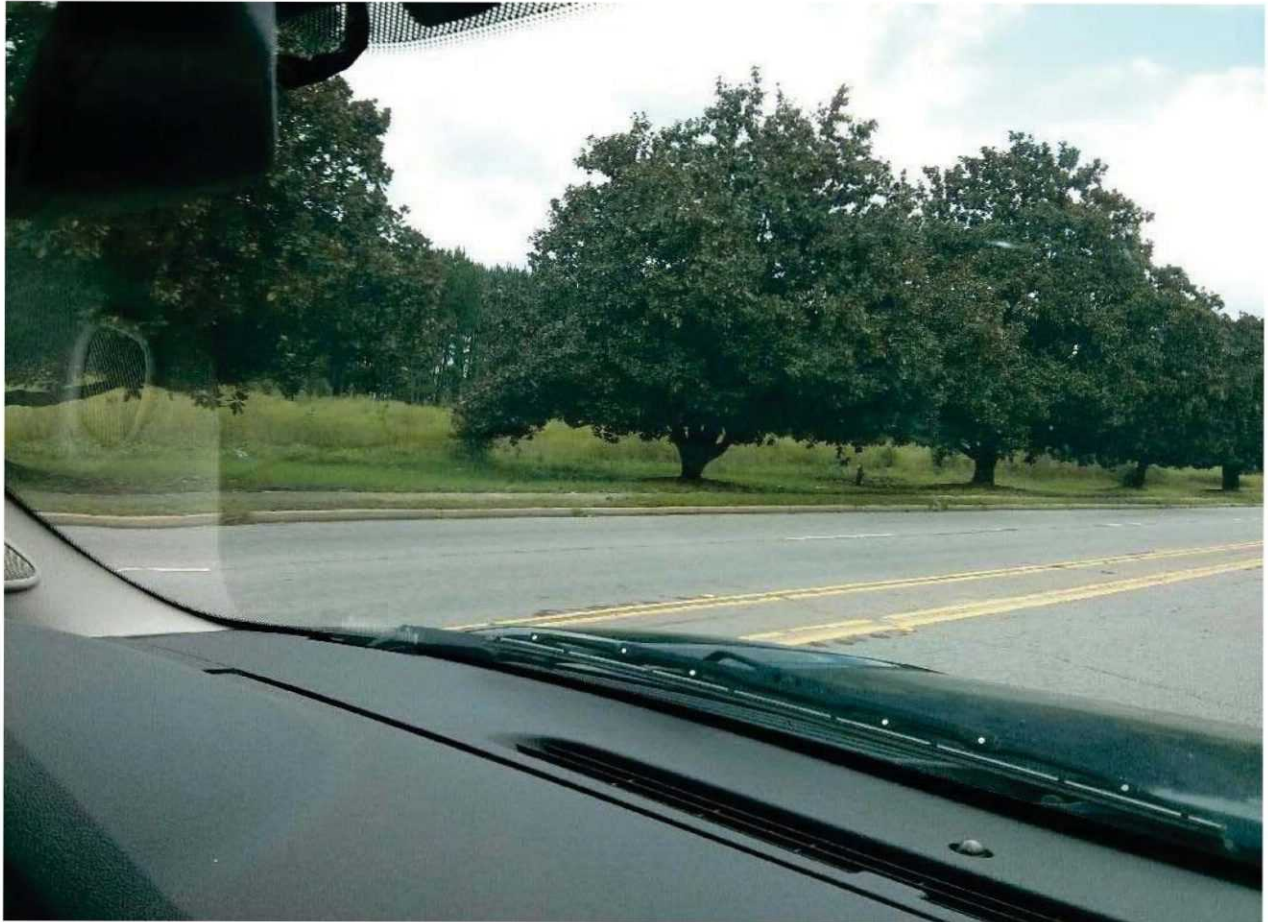
Picture 1 – Former Jaclyn Hosiery Mill – present conditions 9/10/14

The mill itself is torn down, with no evidence of the site's existence other than some paved areas on-site.
